# **The role of geological analysis in the design of interventions for the safety of the road asset. Some examples.**

**Scarano S.<sup>1</sup>, Laureti R.<sup>1</sup>, Serangeli S.<sup>1</sup>**

<sup>1</sup>Anas S.p.A. – Design Management – Geological and geotechnical unit

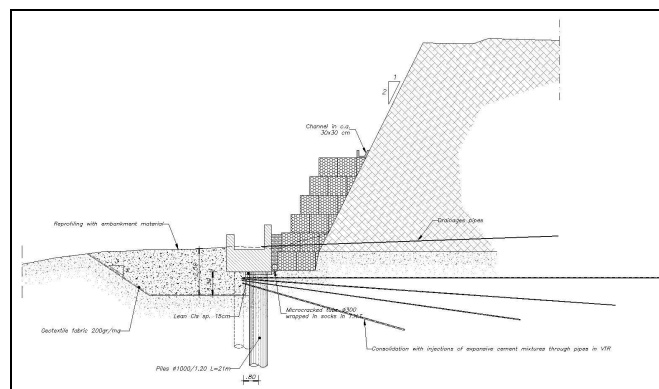
The geological and hydrogeological models, so defined, showed that the sand deposits underlying the road embankment contain an appreciable water circulation that influenced the equilibrium conditions of the roadway. This aquifer is of semi-

confined kind, because it's enclosed between the pliocenic clayey substrate (to the bottom) and a layer of silty clay (to the top). Because of a prolonged infiltration due to the rainfall, the sandy aquifer has developed a growth of the pore pressure and the rising of the piezometric surface. It caused filtration phenomena within the body of the overlying embankment, and the creation of a sliding circular surface, placed immediately behind the reinforced-heart body .

Fig.2.1.3 - Cross section showing the stabilization works

The definitive safety interventions consisted of the realization of a bulkhead of large diameter piles, interventions of consolidation of the soil and, furthermore, of civil works of water gathering.

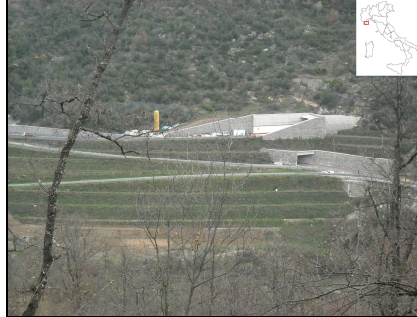
Between the months of October and November 2012, because of the repetition of high intensity and long-term rainy events, a recovery of deformation was recorded, causing the appearance of large tension cracks along the road surface, which led ANAS to define a complete consolidation design of the body of the embankment.

Fig.2.2.1 - Overview, from the opposite slope, of the road interchange

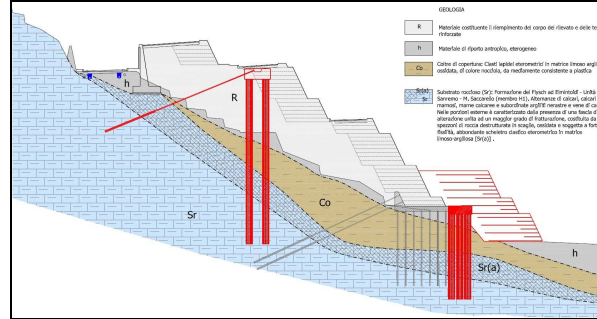
The complex of the acquired data have allowed to identify a reference geological model, represented by a calcareous-marly substrate, belonging to the “Borghetto d’Arroscia-Alassio” and “Moglio-Testico” Units, which with “S. Remo-M. Saccarello” Units constitutes the "Flysch with Elminthoides" Formation of Ligurian-Piedmont Domain. The substrate is covered, in surface, by a layer of eluvial-colluvial deposits, with significant clay content. The site-investigations have also shown the presence of a main sliding surface inside the cohesive materials that covers the bedrock, immediately below the reinforced embankment affected by the deformation, together with evidence of waterflow inside the fractured part of the rock mass.

Fig. 2.2.2 - Cross geological section, completed with the designed stabilization works

So, works of definitive stabilization were realized. They consist of two lines of bulkheads with large diameter piles, with the aim to support the actions of pushing from upstream and to anchor the embankment to the rock substrate. The second bulkhead has been placed on the foot of the embankment and it also reach the bedrock. The works are completed with drainage works along the slope upstream of the embankment.

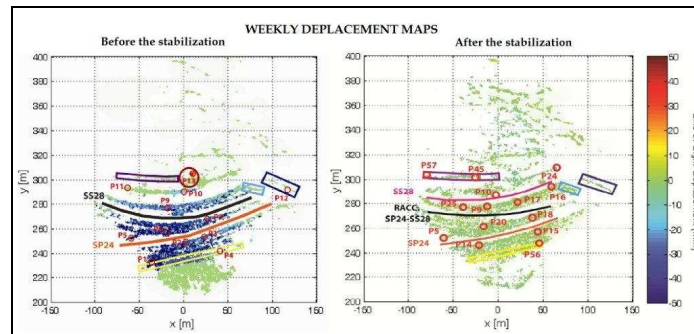
Fig. 2.2.1.1 - Shift TInSAR map before and after the stabilization works

The magnitude of displacement in the following time, from the monitoring network installation, were between -1.5 and -3 mm/day, on approach to the sensor along the line of sight. The embankment has undergone major shifts at the base and in the most western part, while further upstream and eastern portions the movements were more contained. The terrains beyond the foot of the embankment, retaining walls at the entrances of tunnels and the wall on the side of the

embankment, however, have undergone no appreciable movement. The rates recorded over the entire displacement have undergone a gradual deceleration in subsequent periods from the initial movement. Just after the completion of the first measures stabilization (anchored bulkheads) the movements were reduced abruptly to zero.
