Instability of road infrastructures: geological analysis in order to define intervention guidelines

SERENA SCARANO (*), ROBERTO LAURETI (*) & STEFANO SERANGELI (**)

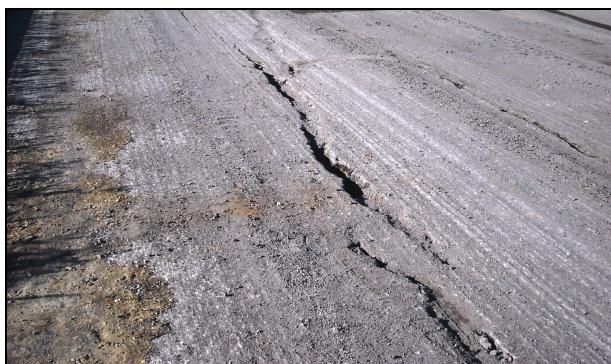
Fig. 1 – Damage on the road as a result of the collapse occurred.

An example (Fig.1) in this regard is provided by part of the "Grande Raccordo Anulare" of Rome between the km 13+700 and 13+800, on external track, and represented by a section of the embankment reinforced soil. This area has been affected by a big deformation phenomenon (about 30 m in longitudinal direction and about 50 m in transverse direction, respect to the deformation), which occurred in December 2010, after a prolonged rainy period, and that has led to the partial closure of

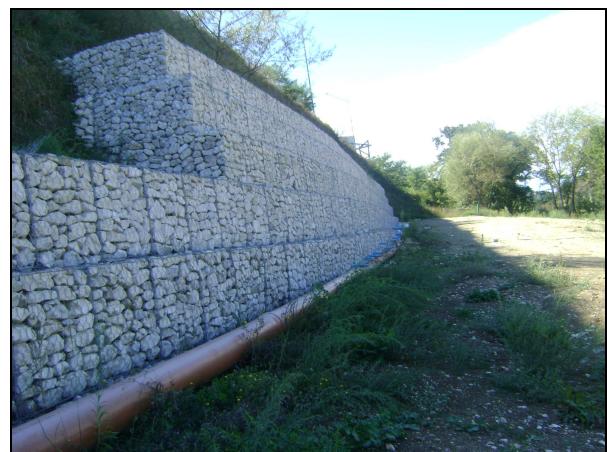
Fig. 2 – Provisional safety measures intervention: installation of metal gabions.

In the first phase of emergency, a temporary intervention was set up through a drainage system and an installation of metal gabions, in order to reduce interstitial overpressures and create an overload at the foot with stabilizing function (Fig.2).
